**IMPACT OF THE PROPOSED CAMPO LANDFILL  
ON THE HYDROLOGY OF THE TIERRA DEL SOL WATERSHED  
A REFERENCE STUDY**

**[Victor M. Ponce](#)**

**May 2006**

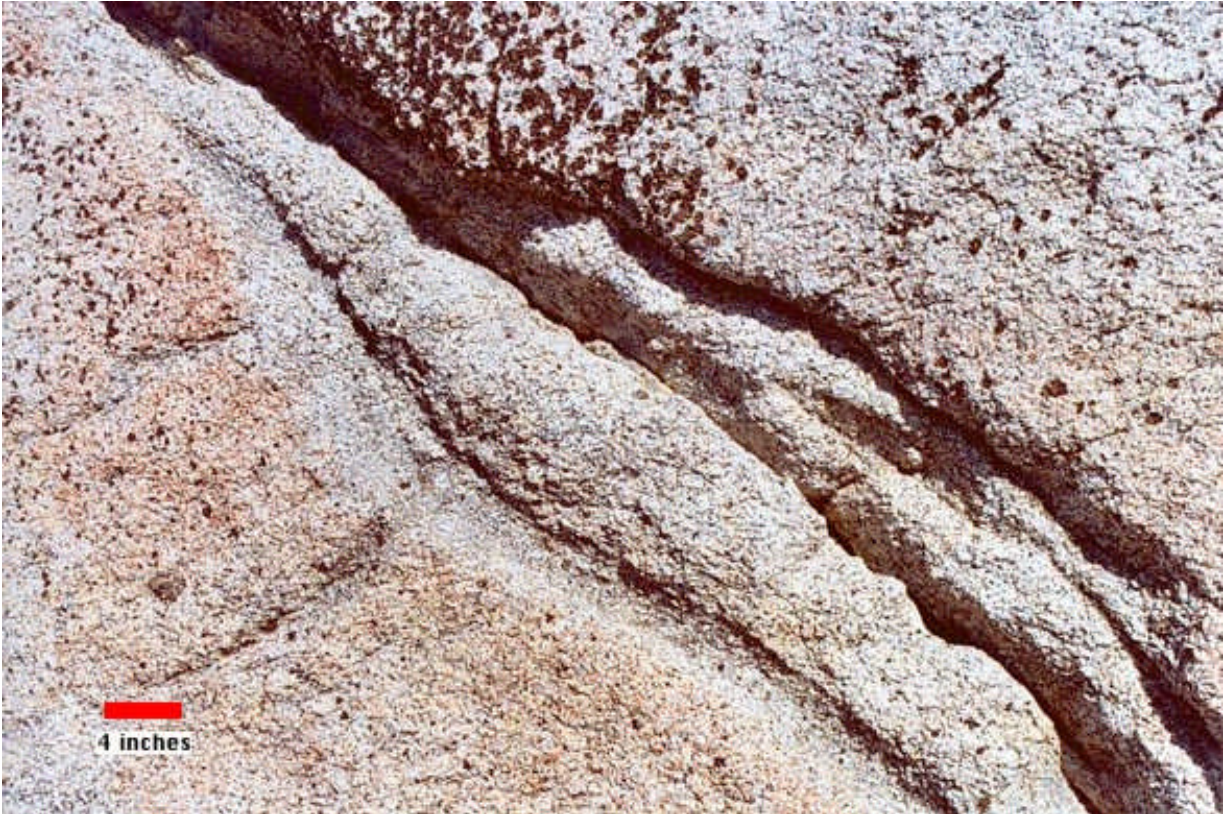
Fig. 1 Closeup of fracture in rock outcrop in the Tierra del Sol watershed.

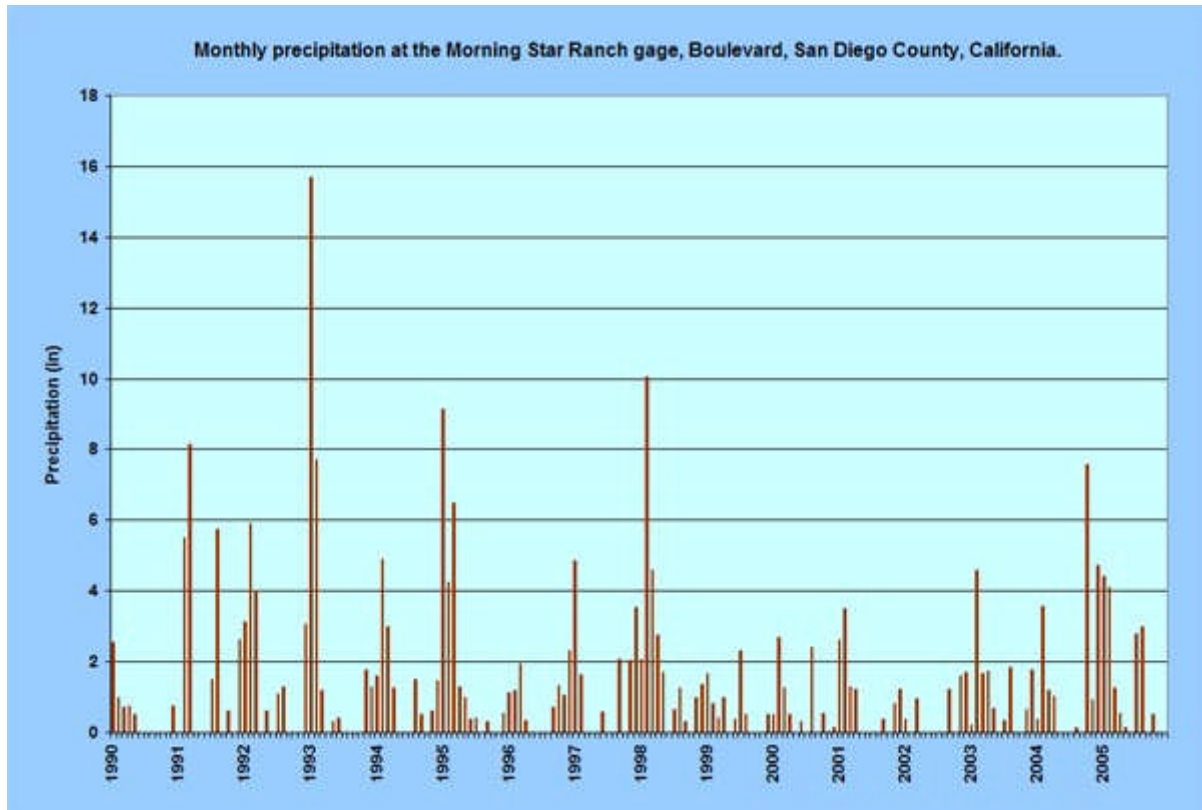
Fig. 3 Monthly precipitation record at the Morning Star Ranch (1990-2005).

**Precipitation data.** Precipitation in the Tierra del Sol watershed has been measured at the Morning Star Ranch from 1990 to the present. The raingage is located at N 32° 37' 27" and W 116° 21' 04". The record of monthly precipitation is shown in Fig. 3. The rainy season is from November to April (winter rains), although there are some documented instances of summer rain. February is the wettest month of record, with 4.09 inches of average precipitation.

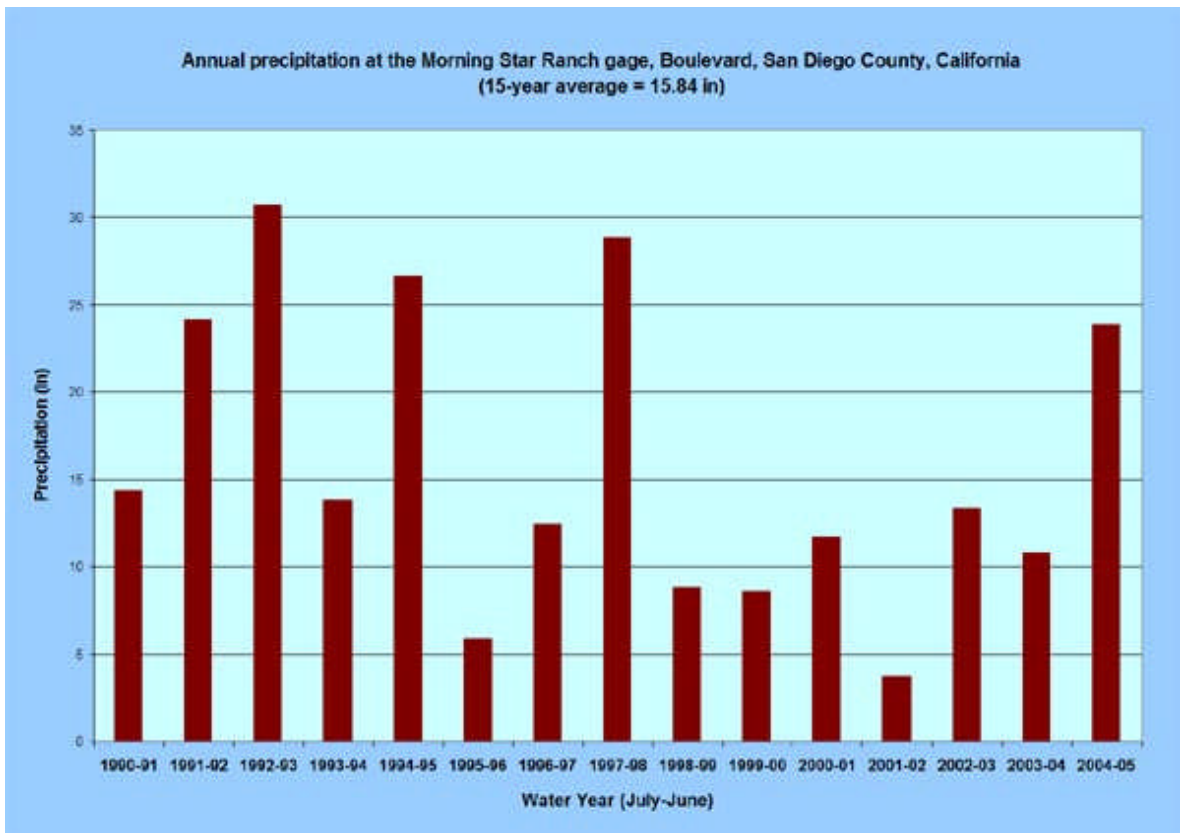
Fig. 4 Annual precipitation at the Morning Star Ranch, 1990-91 to 2004-05.

The record of annual precipitation, with the water year defined from July to June, is shown in Fig. 4. The average precipitation for the 15-year period is 15.84 inches. The record shows two very wet years, 1992-93 and 1997-98; and three other significantly wet years, 1991-92, 1994-95, and 2004-05. The years 1991-92, 1992-93, 1994-95, and 1997-98 were El Niño years. In the year 2004-05, monthly and annual precipitation were near record highs.

The years 1995-96 and 1998-99 were La Niña years, showing substantially below average precipitation. A La Niña event is the opposite of an El Niño, leading to cooling, instead of warming, of the sea-surface temperatures (SST) in the Pacific Ocean along the equator.

In summary, the precipitation record shows two very wet years (1992-93 and 1997-98), and one significantly wet year (2004-05), the latter following at the end of a persistent six-year drought (1998-99 to 2003-04).

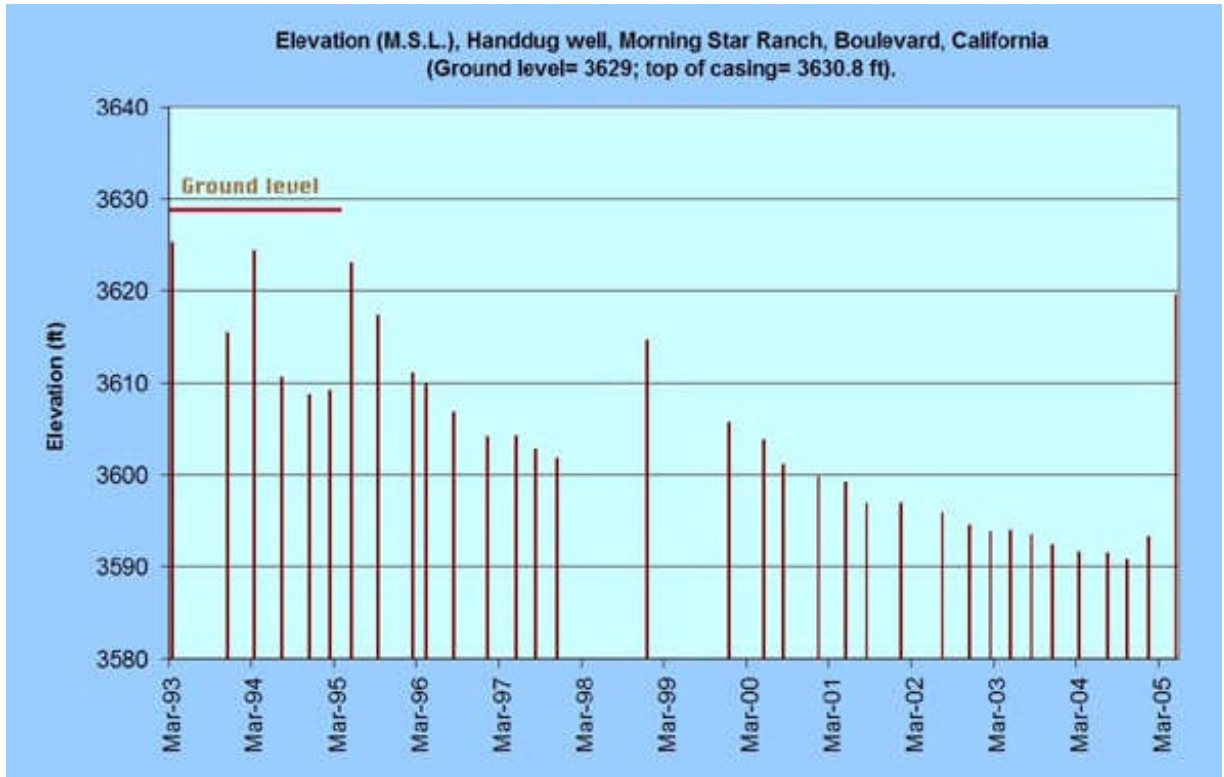
Fig. 6 Water-surface elevation at Handdug well.

**Well data.** Well data spanning the 12-year period from 1993 to 2005 is shown in Figs. 6 to 8. Fig. 6 shows the Handdug well, Fig. 7 shows the Playhouse well, and Fig. 8 shows the Utz well. The measurements were performed by San Diego County personnel as part of the county's groundwater monitoring program. The elevations shown are the water surface in the well, above mean sea level.

The records shows a clear recovery of the groundwater levels in the years 1995, 1998, and 2005, indicating the effect that these three wet years had on aquifer replenishment. Significantly, all three wells show water table drawdown during the six-year drought period ranging from 1999 to 2004. Furthermore, the two dry years of 1995-96 and 1996-97 also show some degree of water table drawdown.

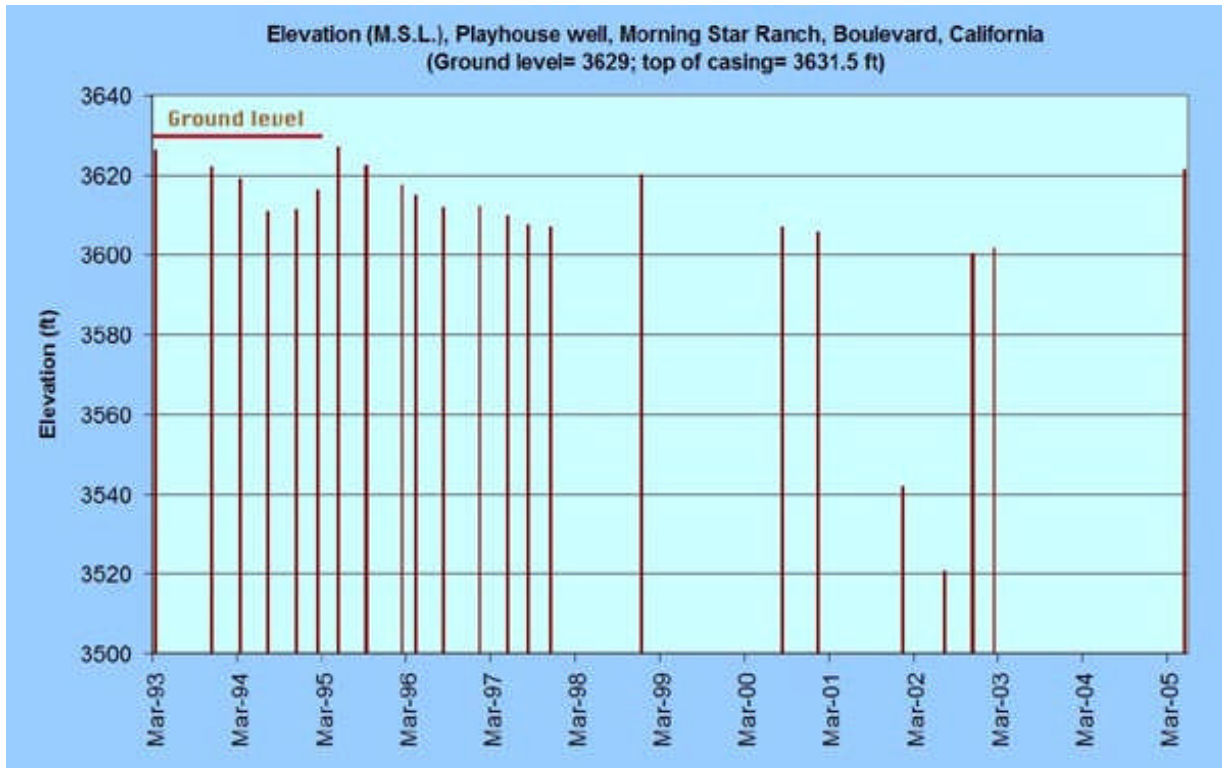
Fig. 7 Water-surface elevation at Playhouse well.

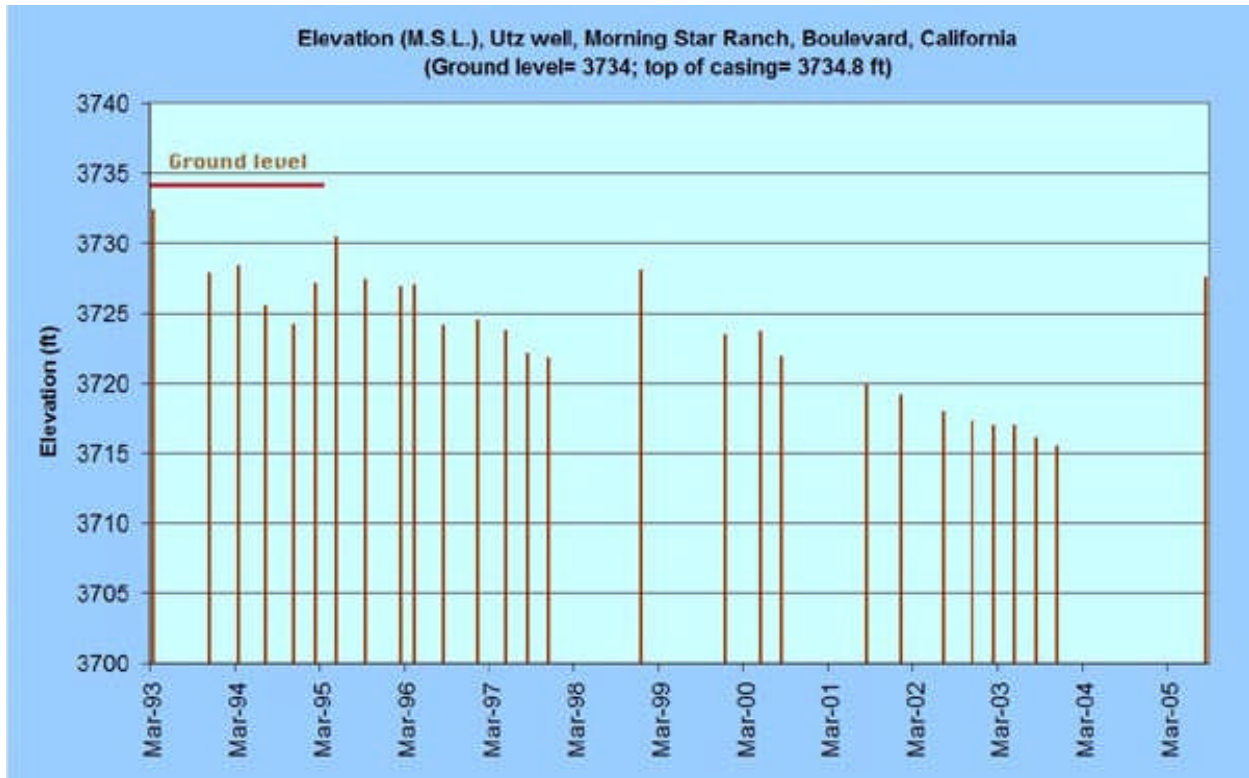
Fig. 8 Water-surface elevation at Utz well.

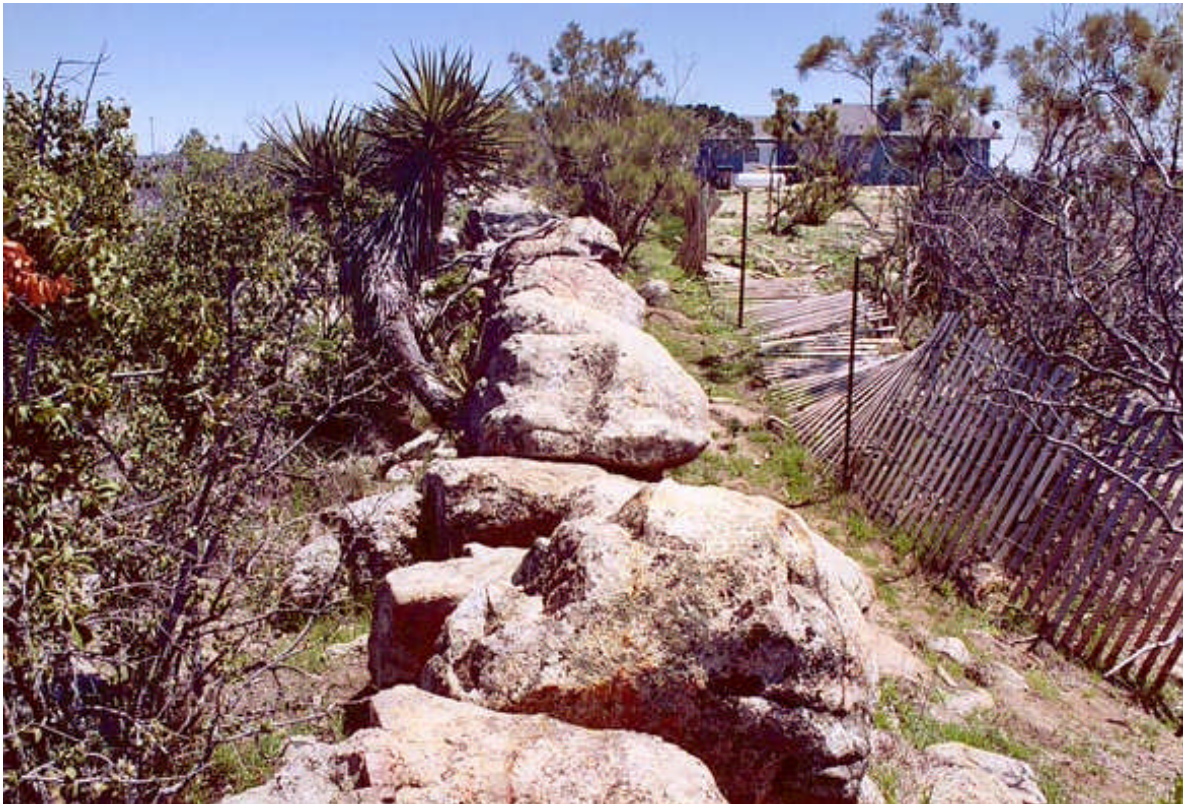
Fig. 10 Major dike in Turner Ranch, Tierra del Sol.<sup>8</sup>

A striking geological feature of Tierra del Sol, and one possibly related to the fractures, is the significant number of white, mostly pegmatitic, seemingly vertical dikes that cut across the study area. These dikes are formed by quartz and feldspar-rich magmas left over in the final stages of crystallization of the granitic rocks. Since the age of the fractures is not known with certainty, the relation between the dikes and the fractures is not readily discernible. One possibility is that the dikes were injected into the fractures which formed in the initial stages of crystallization and cooling of the granitic rocks. This would place the age of [at least] some of the fractures at about 90-140 million years old (Deméré, 2006). Another possibility is that the fractures formed as a result of stresses produced during the [later] uplift of the Peninsular Ranges. In this case they would be only a few million years old.

It is not immediately apparent which one of the above two scenarios is more plausible. If the fractures preceded the dikes, an east-west preference in dike orientation would suggest that less energy was required to shoulder aside the rock in an orthogonal (i.e., north-south) direction. In turn, this would imply denser fracture spacing and/or greater fracture lengths and widths in the east-west direction. One significantly major dike located on the Turner Ranch in Tierra del Sol, is about 5-ft wide and 1,465-ft long (Fig. 10). Notably, this dike trends east-west almost exactly (Fig. 20). A geologic fault crosses this dike near its eastern edge, in an approximate NE-SW direction. Significantly, the Turner Ranch's well is located at or near this fault.

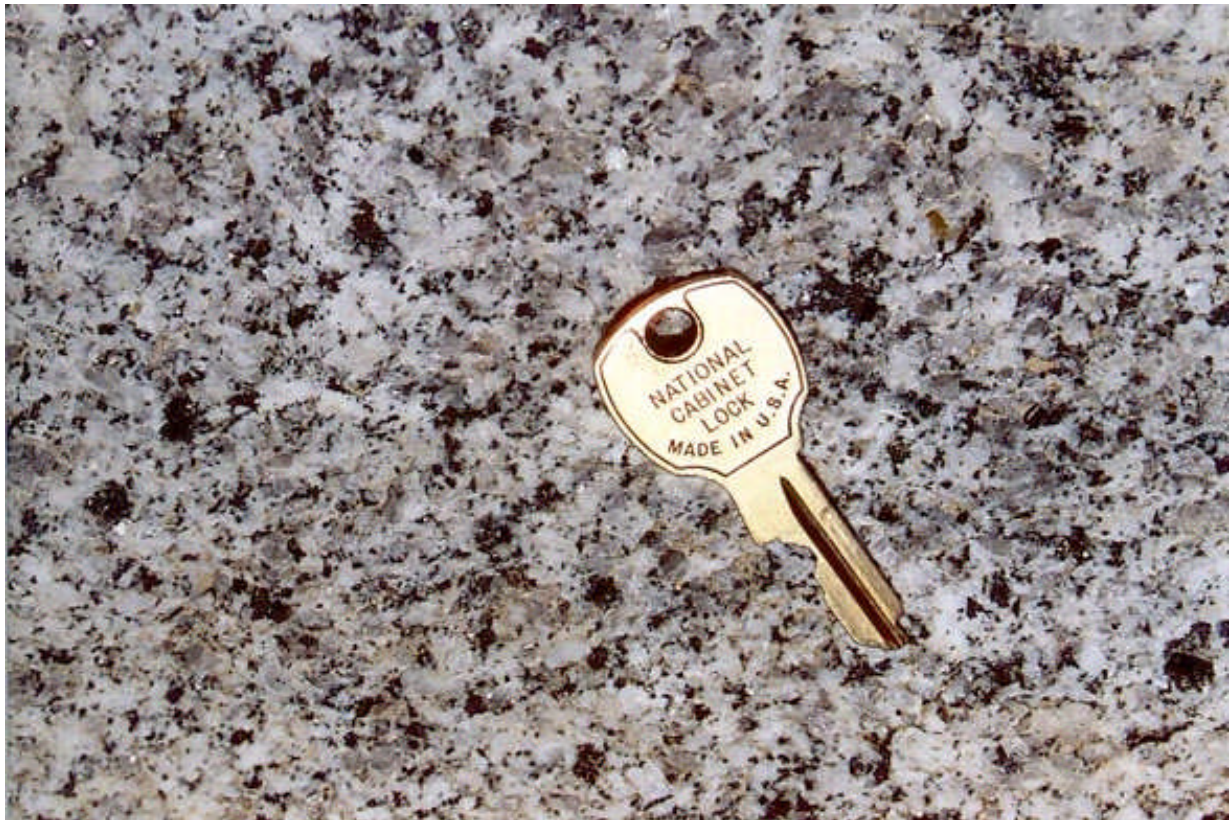
Fig. 12 Closeup of matrix structure in rock outcrop at Tierra del Sol.

**Variability in well yield.** Well yield is a function of hydraulic conductivity. In fractured rock, water-bearing fractures are responsible for most of the yield, with very little of it originating from matrix flow. Thus, well yield is directly related to the number, size, and orientation of existing fractures. To put it concisely, where there is a significant presence of fractures, generally there is ample water; conversely, where there is ample water, its presence may be attributed to a significant number/size of fractures. In general, very little yield could be expected from the rock matrix (Fig. 12).

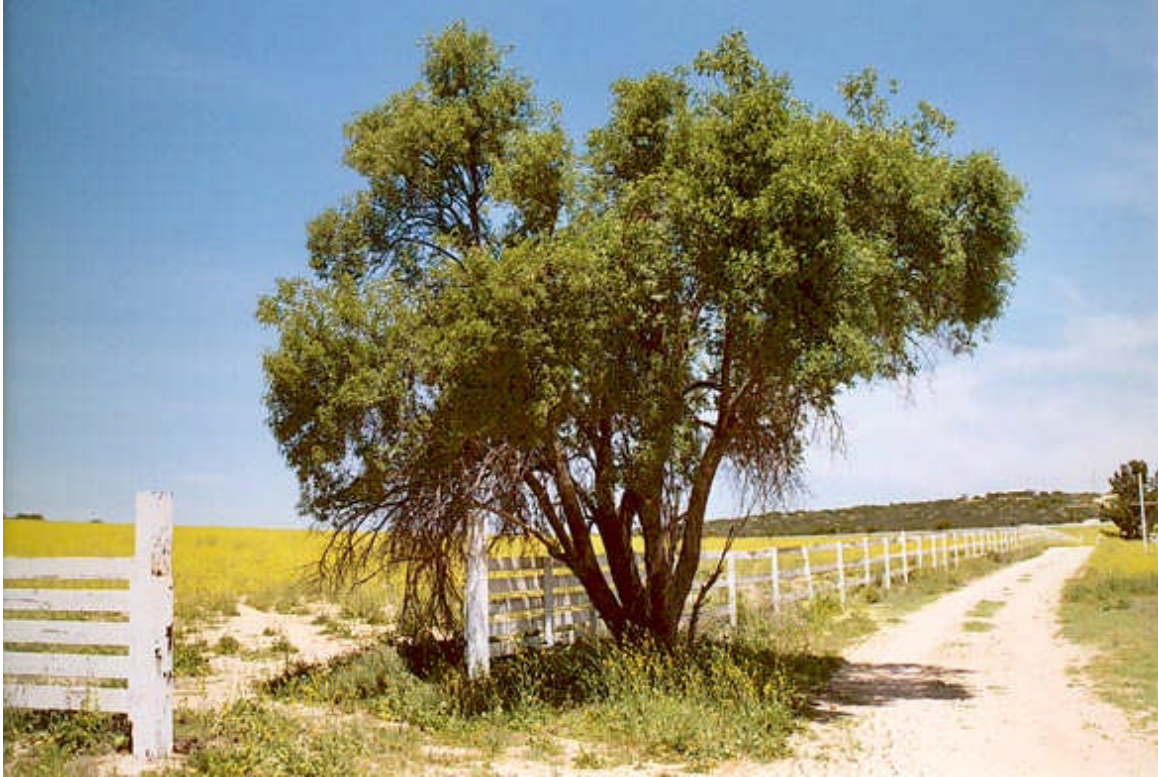
Fig. 13 Specimen of blue elderberry, Morning Star Ranch, Tierra del Sol watershed.<sup>12</sup>

**Blue elderberry.** Under moist conditions, such as near the bottom of ravines or small canyons, the chaparral coexists with the small woody winter-deciduous *Sambucus* species and the flowering ash (*Fraxinus dipetala*) (Keeley and Keeley, 1988). One *Sambucus* species, the blue elderberry (*Sambucus mexicana*) is present in the flood plains and other mesic locations of the Tierra del Sol watershed (Fig. 13).

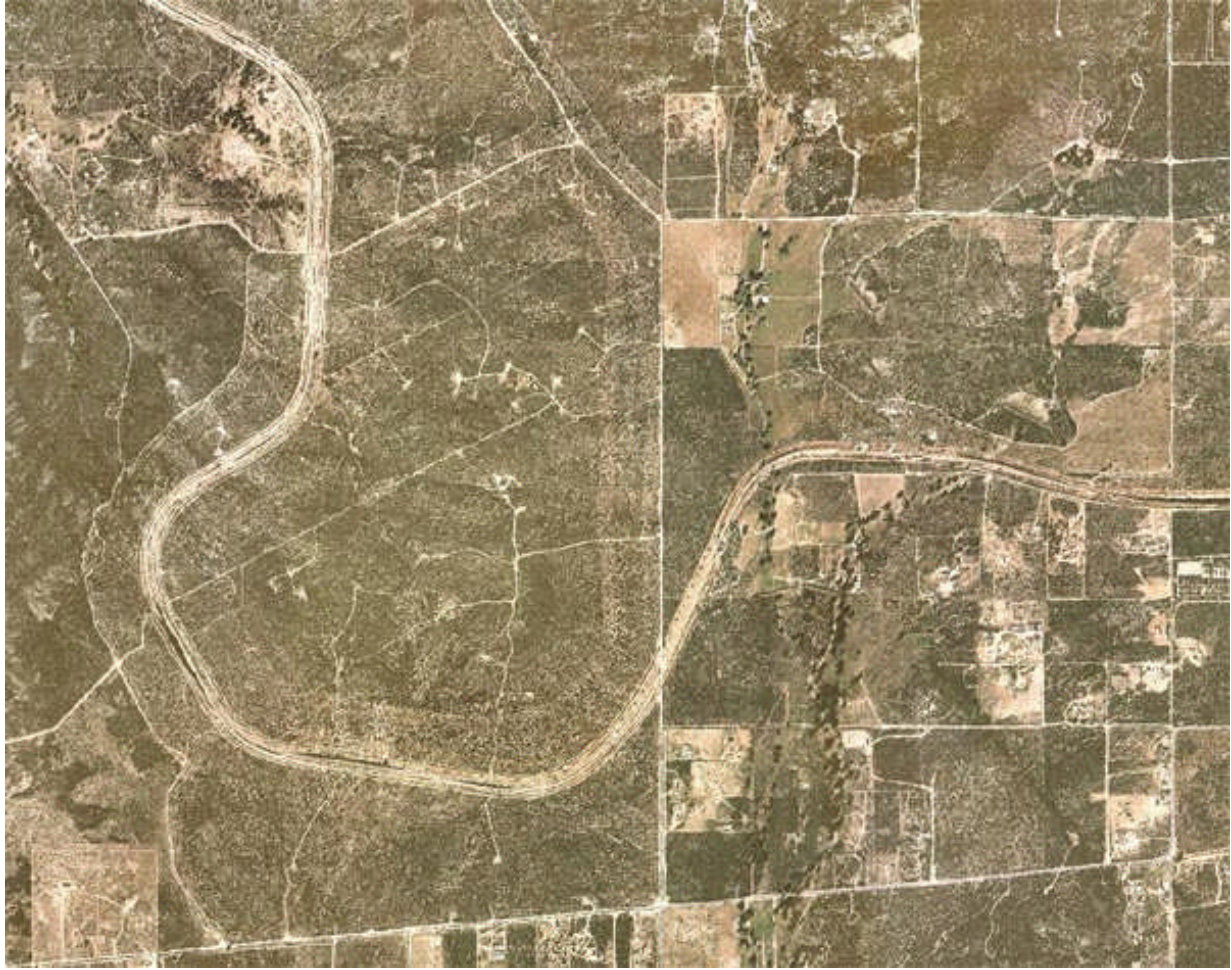
Source: GIS, Department of Public Works, San Diego County.  
Fig. 15 Larger-scale image of the study site.<sup>14</sup>

**Remote sensing.** Figures 15 to 17 show color images of the proposed landfill site at three different spatial scales, from larger (Fig. 15) to midsize (Fig. 16) to smaller (Fig. 17). These images show the presence of darker spots of approximate longitudinal orientation, referred to as lineaments. They appear as such or are evident due to contrasts in terrain or ground cover on either side. If they are of geological origin, the lineaments are usually traced to faults, joints, or boundaries between stratigraphic formations. When they are related to bedrock features, they are most readily observed in areas where the surficial material is thin (Moore *et al.*, 2002). This is certainly the case in the Tierra del Sol watershed.

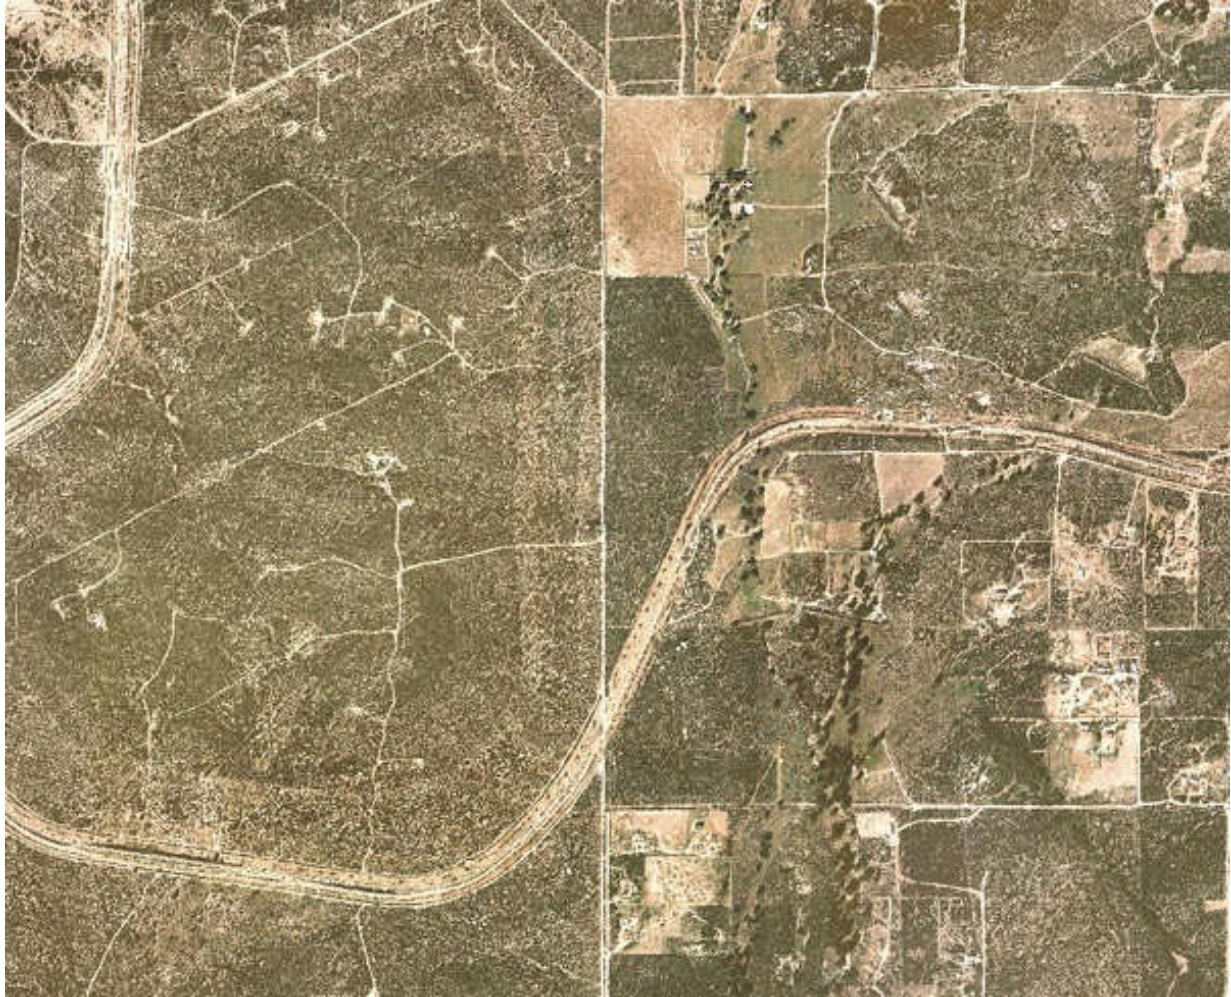
Fig. 16 Medium-scale image of the study site.<sup>14</sup>

A substantial number of major lineaments can be observed at all three image scales. Figure 16, in particular, shows a clearly defined lineament located east of Tierra del Sol Creek, close to the bottom right-hand corner of the figure, with a predominant northwest to southeast direction. Field inspection showed that this lineament is constituted by thick stands of red shank (*Adenostoma sparsifolium*), in association with specimens of scrub oak (*Quercus dumosa*), some of which are distinctively large. This observation confirms that red shank prefers a more mesic (i.e., humid) environment than its congener the chamise (Beatty, 1984). Several other red-shank dominated lineaments crossing the boundary between the landfill site to the west and the Tierra del Sol watershed to the east have been observed.

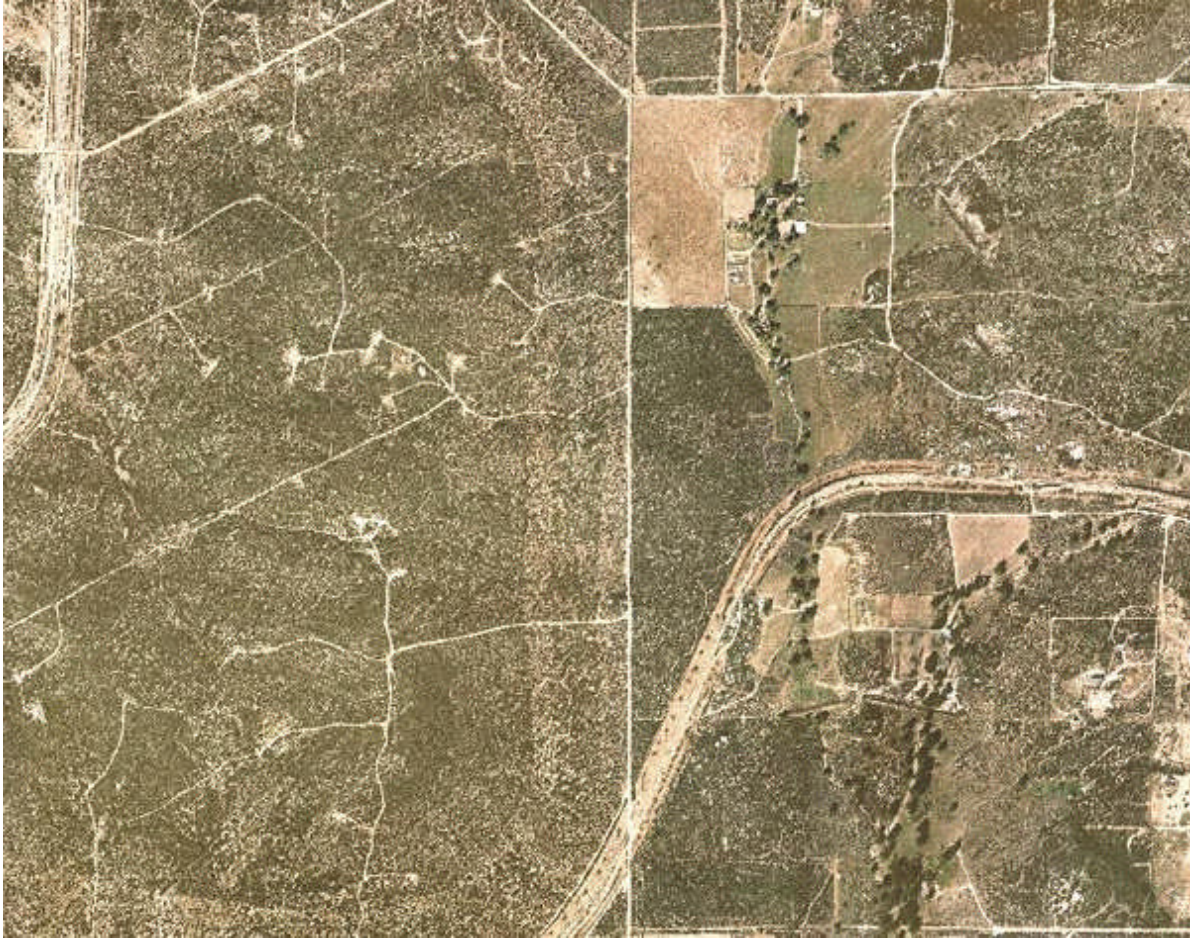
Fig. 17 Smaller-scale image of the study site.<sup>14</sup>

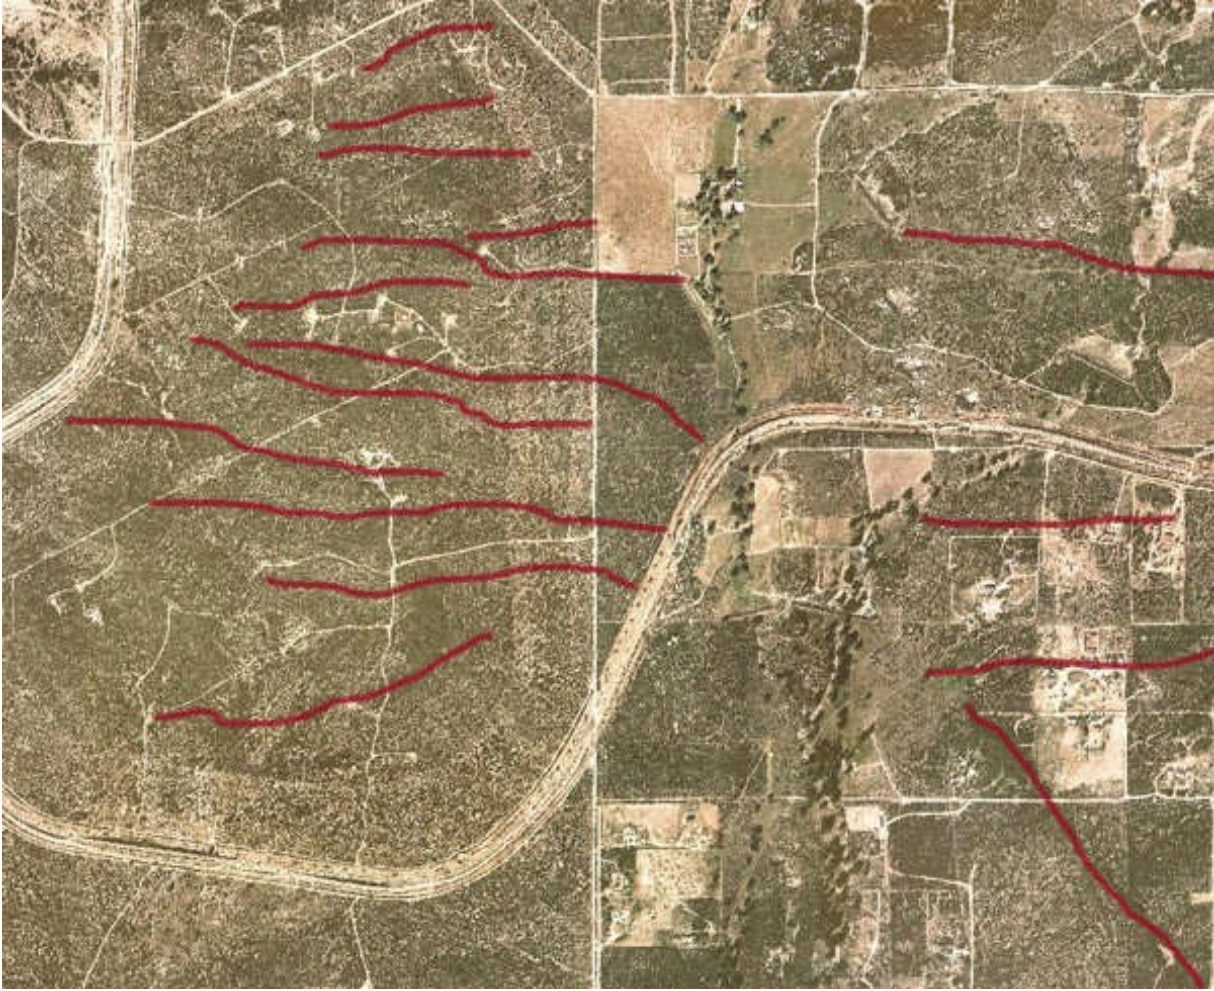
Fig. 18 Readily identifiable lineaments in the Campo landfill-Tierra del Sol site.<sup>14</sup>

Figure 18 is the same as Fig. 16, but with readily identifiable lineaments, from photo inspection and field verification, highlighted in red. The interpretation of this image is that it is underlain by an extensive system of fractures. There appears to be no other sensible explanation for the presence of the lineaments. Field observations and local experience support this statement.

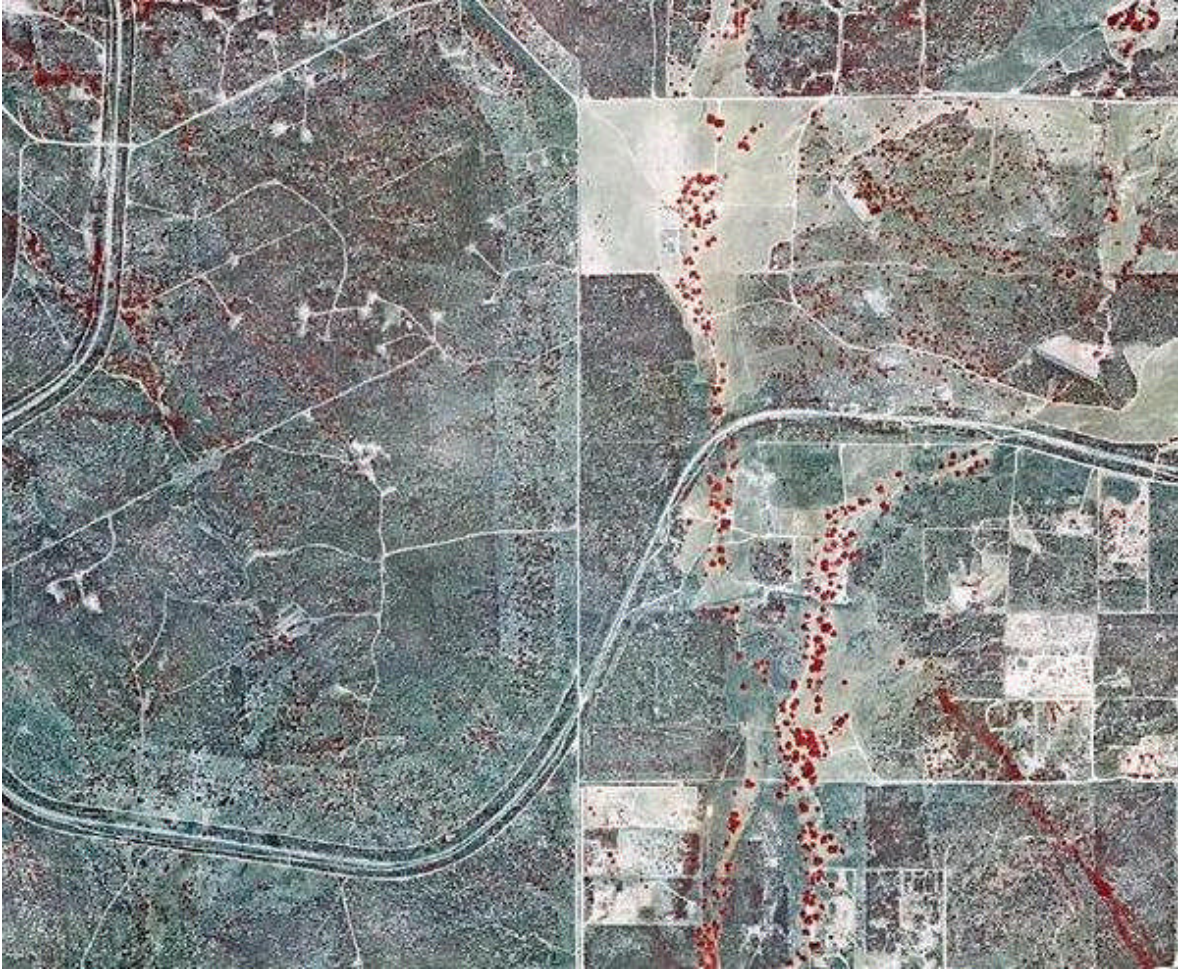
Fig. 19 Infrared image of the Campo landfill-Tierra del Sol site.<sup>15</sup>

Figure 19 shows an infrared image covering the same area as Fig. 18. Many of the lineaments highlighted in Fig. 18 can be observed in Fig. 19. Predictably, the major drainage courses (Tierra del Sol Creek and tributaries) feature riparian forests, which draw their moisture from the groundwater (vadose and phreatic zones). The lineament in the bottom right-hand corner is located upland, i.e., it does not follow any clearly defined watercourse. Yet it is seen to consist of large shrubs (red shank) and trees (oak species) with a demonstrated water affinity.

oak (*Quercus agrifolia*), shown in Fig. 22. This tree appears in Fig. 19, at the western edge of the dike (compare Figs. 19 and 20). Although drought tolerant, a coast live oak requires some moisture for its normal development. Thus, the presence of an oak specimen near a spring in the Tierra del Sol watershed is further evidence of a hydraulic connection between surface water and groundwater.

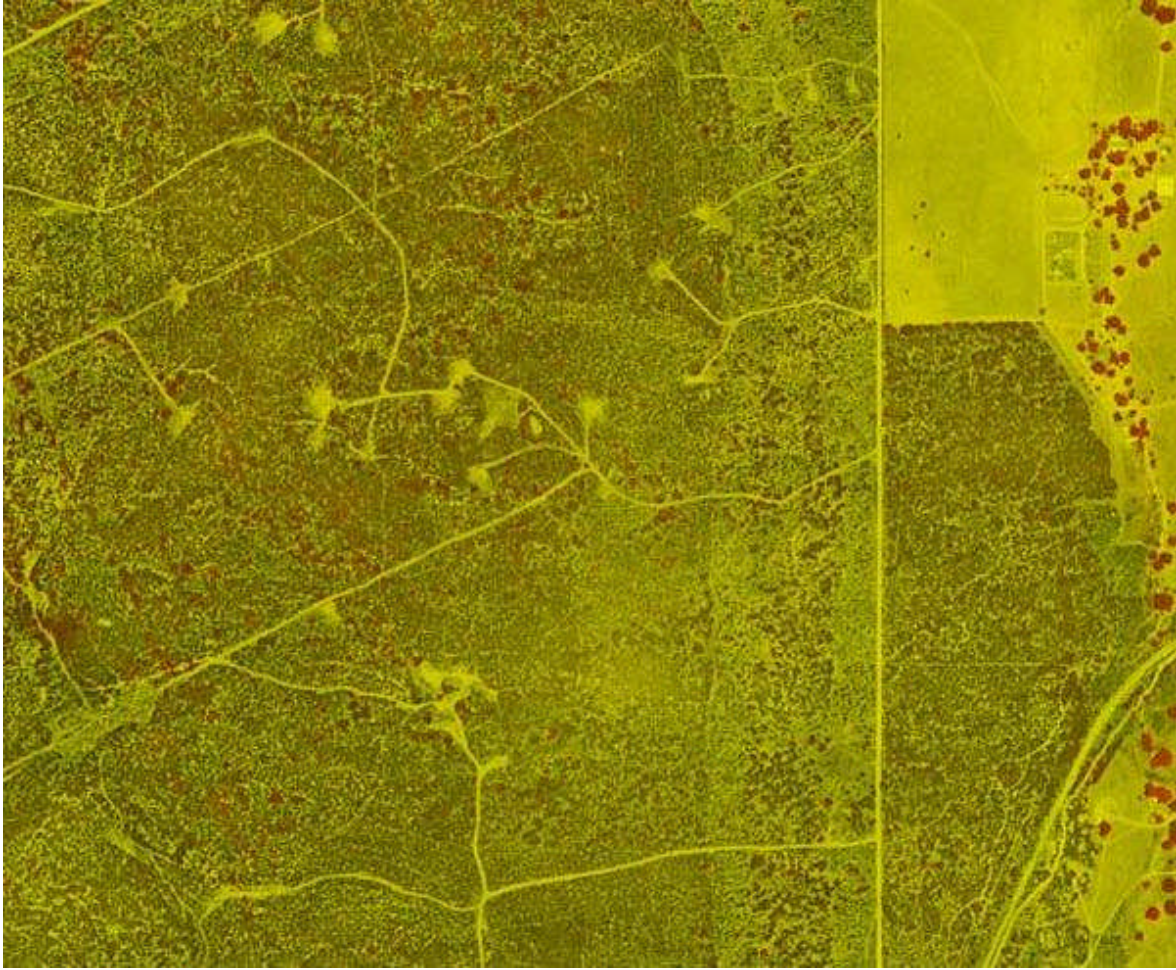
Fig. 20 Digitally enhanced image of the Campo landfill-Tierra del Sol watershed boundary.<sup>15</sup>

Figure 20 shows a digitally enhanced image of the central portion of the Campo landfill-Tierra del Sol site. To obtain this figure, Fig. 19 was processed with the NDVI<sup>16</sup> feature of the ERMapper image-processing software, and cropped to the region of interest. Many of the lineaments depicted in Fig. 18 are clearly visible in Fig. 20.

In Fig. 20, note that the southernmost spring is located precisely at the western extremity of the 1,465-ft dike shown in Fig. 10. This spring sustains a rather large isolated specimen of coast live

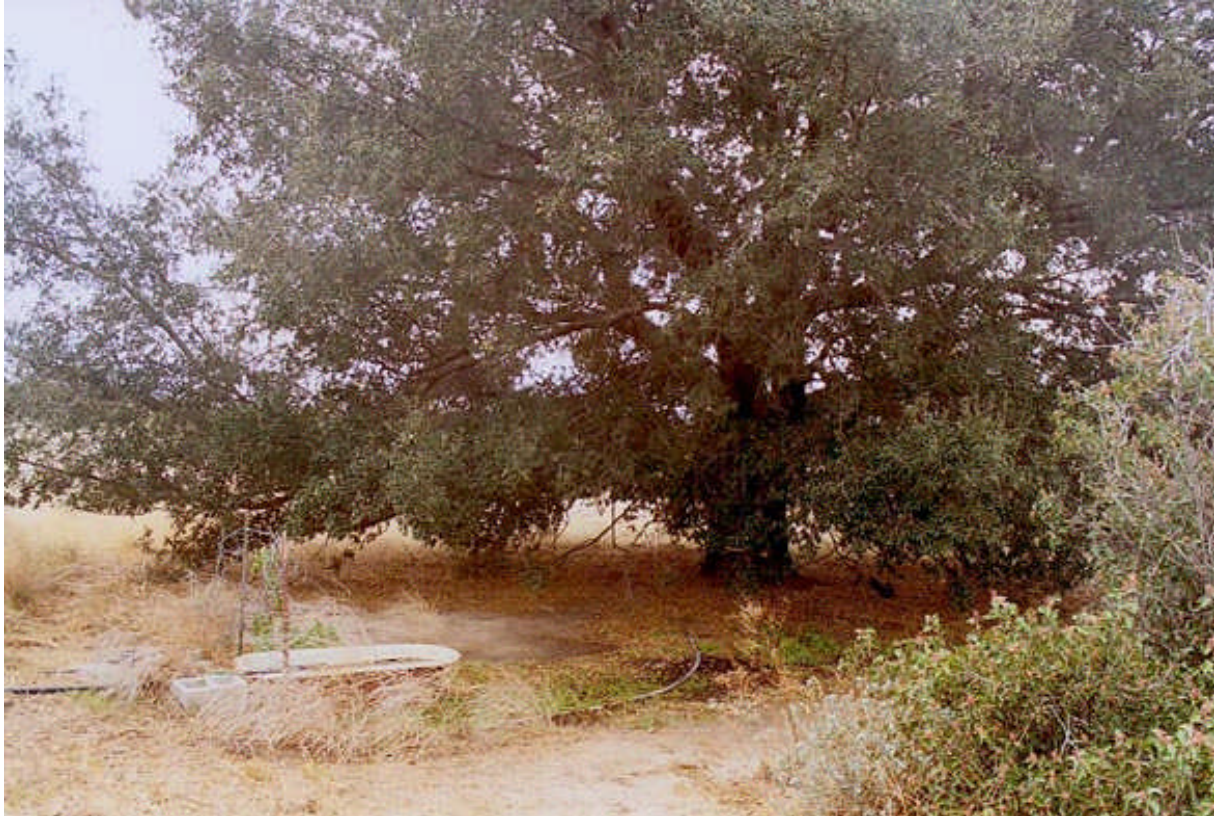
Fig. 22 A coast live oak near west end of southernmost spring in the Tierra del Sol watershed. Note the presence of substantial moisture on the ground.<sup>17</sup>

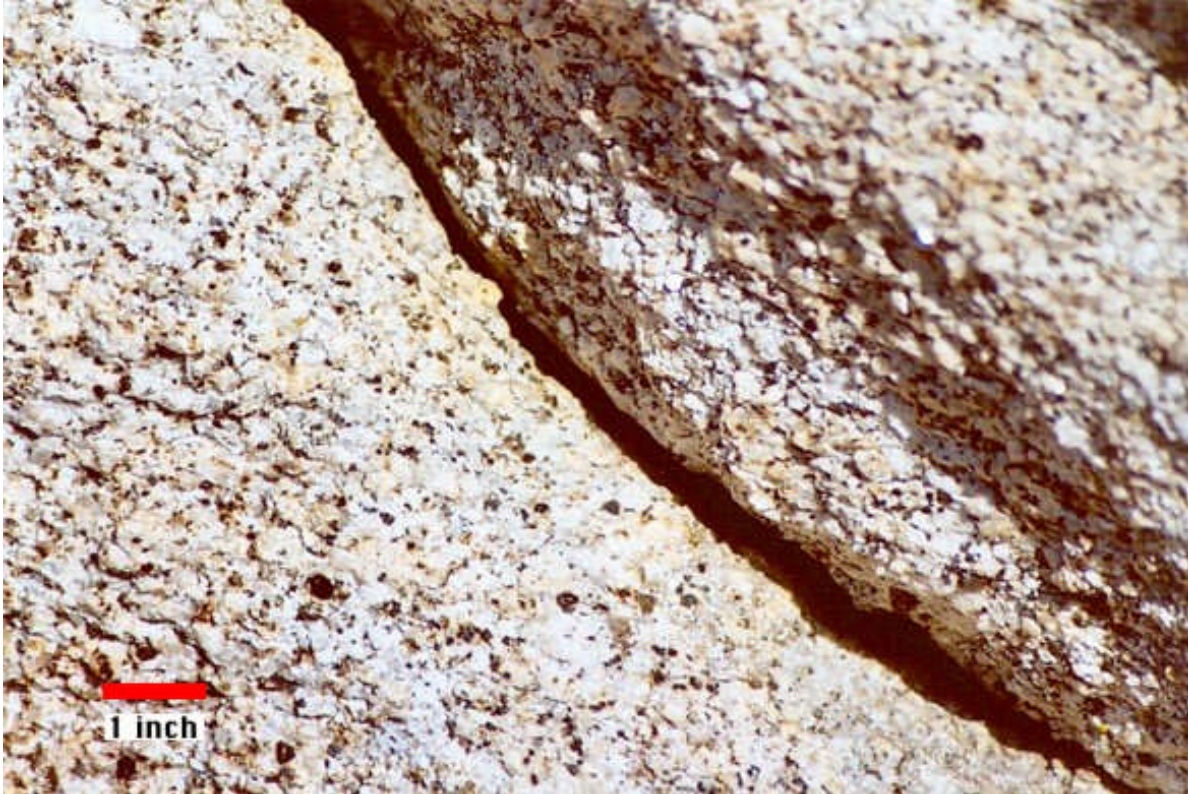
Fig. 23 Closeup of fracture in rock outcrop at Tierra del Sol.

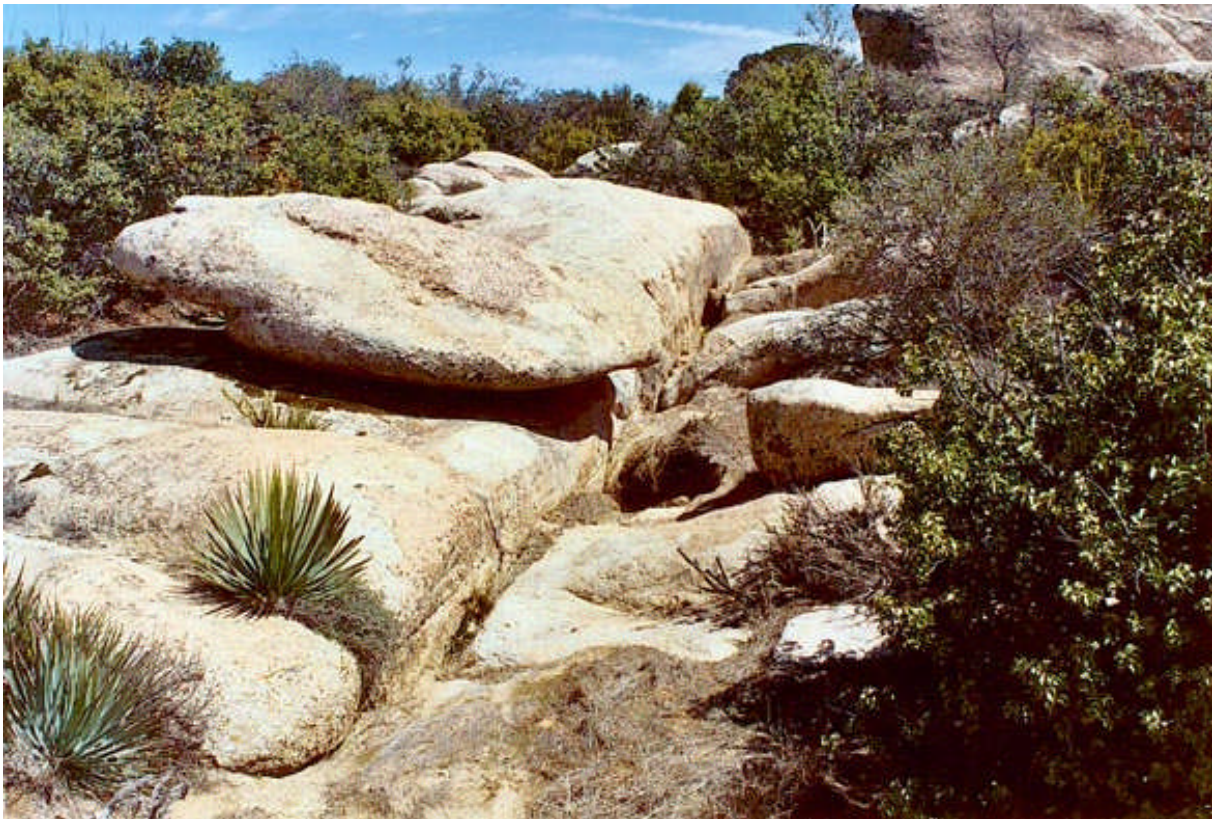
Fig. 24 Fracture in rock outcrop in Tierra del Sol watershed.<sup>21</sup>

Existing fracture maps show the extent to which the underlying aquifer contains fractured rock that would render the aquifer difficult to characterize (Fig. 24). Fractured-rock aquifers of the type found in the Campo-Tierra del Sol site are heterogeneous and anisotropic. Hydraulic conductivities in fractured-rock aquifers can vary greatly, typically six (6) orders of magnitude, but could be vary up to ten (10) orders of magnitude in some instances.

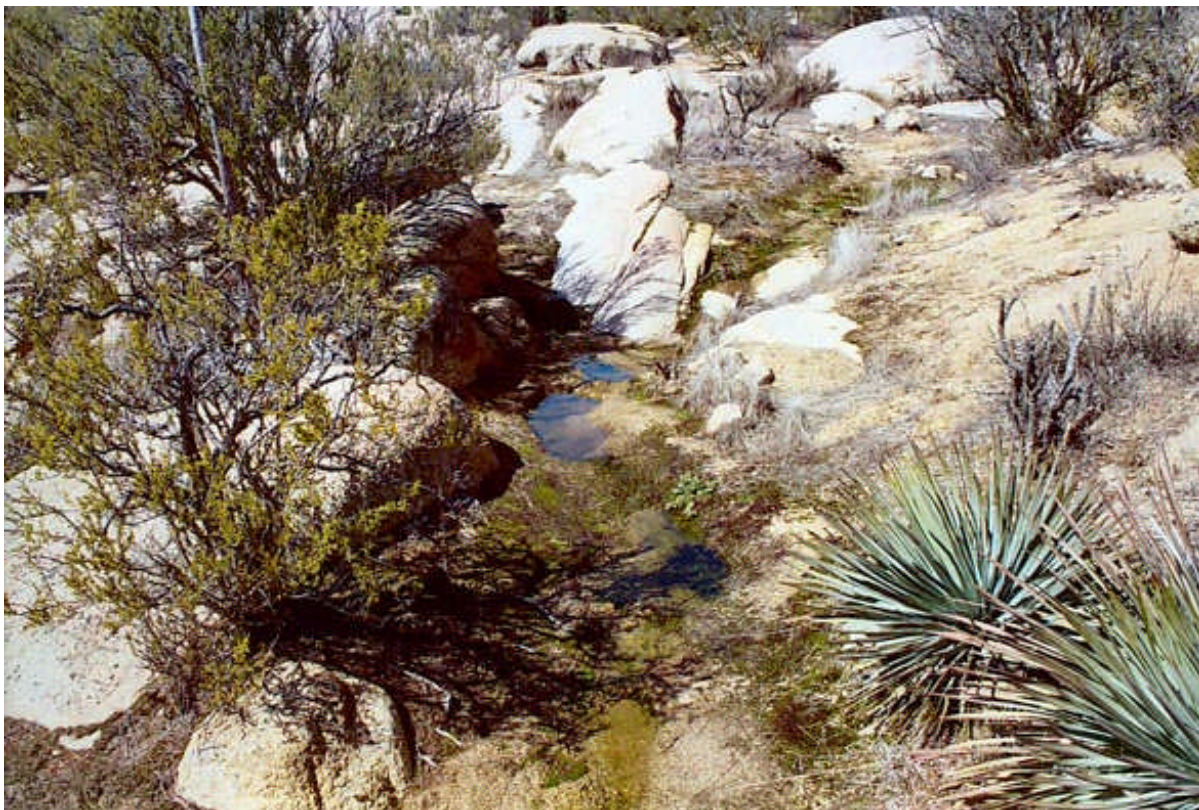
Fig. 25 Spring in rock outcrop in northern slope of Tierra del Sol watershed at N 32° 37' 21.6" and W 116° 20' 39".<sup>21</sup>

Springs in the Tierra del Sol watershed primarily drain its northern slopes (Fig. 25). The absence of major spring presence on the western slopes would seem to indicate that drainage across the Campo-Tierra del Sol watershed boundary is primarily through the subsurface, from the fractures to the streams. The presence of a large coast live oak (*Quercus agrifolia*) in the immediate vicinity of a spring (Fig. 21) is live evidence of an effective hydraulic connection between surface water and groundwater.
