**IMPACT OF THE PROPOSED CAMPO LANDFILL  
ON THE HYDROLOGY OF THE TIERRA DEL SOL WATERSHED  
A REFERENCE STUDY**

**[Victor M. Ponce](#)**

**May 2006**

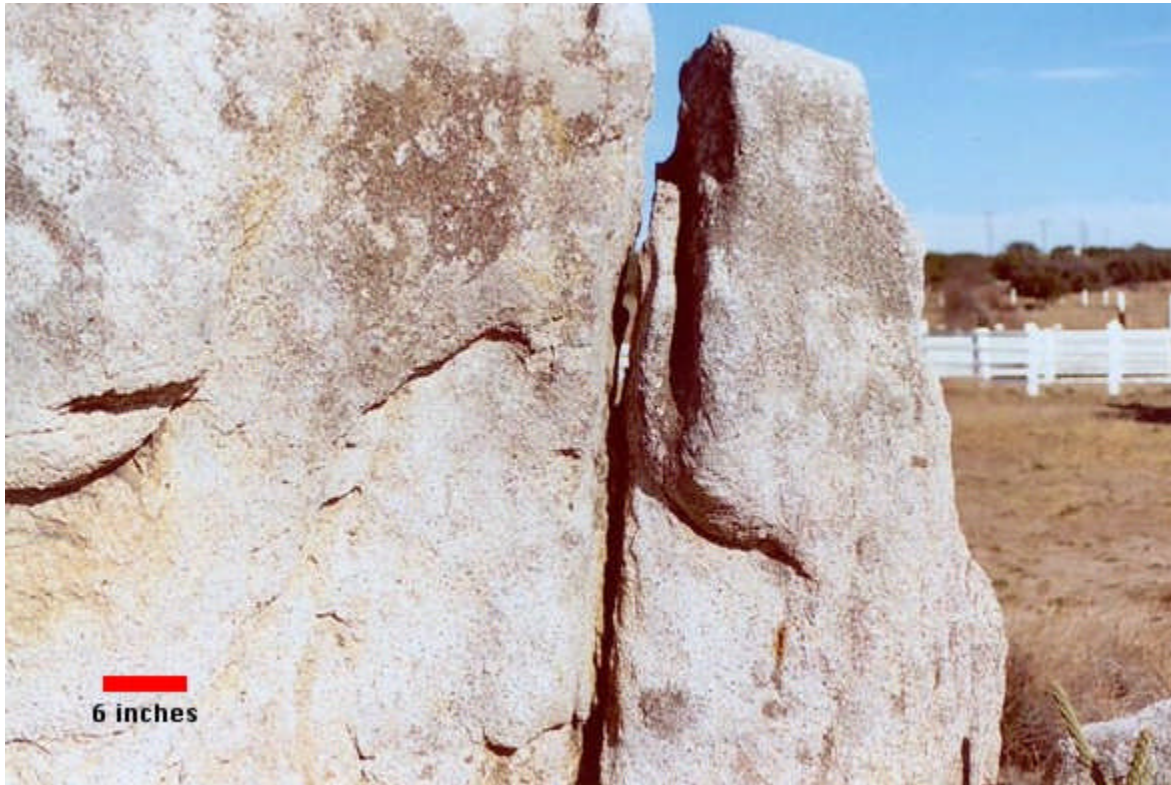
Fig. 26 Fractured rock outcrop, Tierra del Sol watershed.
